STORMWATER COMPLIANCE INSPECTION REPORT

WADOE Stormwater

PHOTO ADDENDUM - ARDAGH GLASS 11/20/18

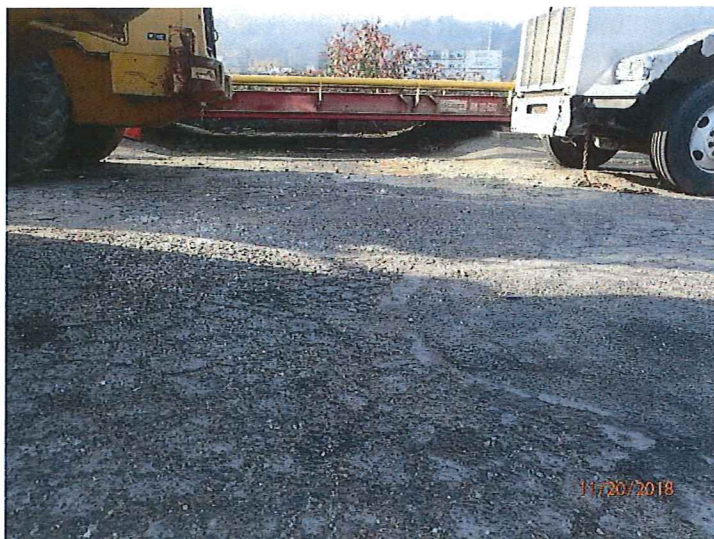
- The majority of the site is paved. Alligator cracking and other pavement damage was observed throughout the site. The poor pavement condition likely reduces sweeping efficacy and contributes to sediment and debris control issues on-site.

001 DESCRIPTION: ALLIGATOR CRACKING OF PAVEMENT.

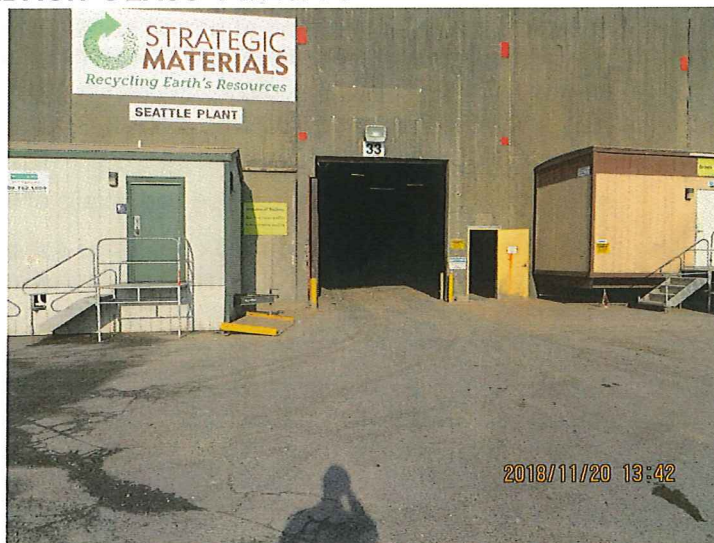
- Vacuum sweeping of the site is conducted on a weekly basis. Sweeping is conducted by both a street sweeping contractor and by using small, ride-on industrial shop sweepers that are owned by the facility. Despite sweeping activities, significant accumulation of sediment, dust, and particulate debris was observed in multiple locations on-site. Sediment and debris accumulation was particularly high in the drainage basin for outfall 3. The majority of industrial activities in this drainage basin are conducted by Strategic Materials, a tenant of Ardagh Glass that sorts and processes glass for recycling. Track out of fine debris particles from inside Strategic Materials' operations building onto the outside pavement was observed. Piles of debris were also observed on the pavement outside of the Strategic Materials building. Additional areas of heavy sediment and debris accumulation were observed near the bag houses in drainage basin 1 and around large objects (e.g. dumpsters) throughout the site that may not be easily accessed by the street sweepers. We discussed the need for improved sediment control with L. Getubig, as the BMPs currently employed do not provide all known, available, and reasonable methods of prevention, control, and treatment (AKART).

002 DESCRIPTION: TRACK OUT OF FINE DEBRIS FROM STRATEGIC MATERIALS BUILDING AND SMALL PILES OF DEBRIS OUTSIDE OF DOORS.

- **Ardagh Glass is in violation of permit condition S10.C, failure to apply all known and reasonable methods of prevention, control, and treatment (AKART) for the management of sediment, dust, and particulate debris on-site.** Within 30 calendar days of receipt of this report develop and implement a plan to better control sediment, dust, and particulate debris on-site. Ensure that the SWPPP is updated to reflect any changes in BMPs.

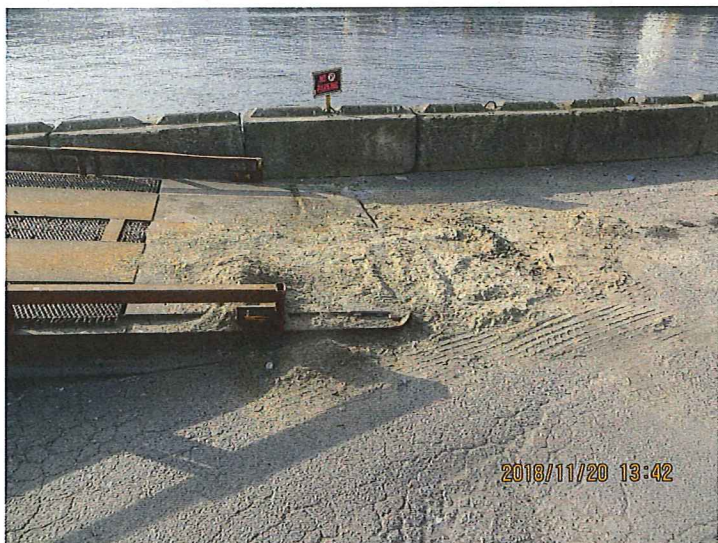
003 DESCRIPTION: PILE OF FINE DEBRIS ON PAVEMENT ALONG THE DUWAMISH RIVER IN DRAINAGE BASIN 3.

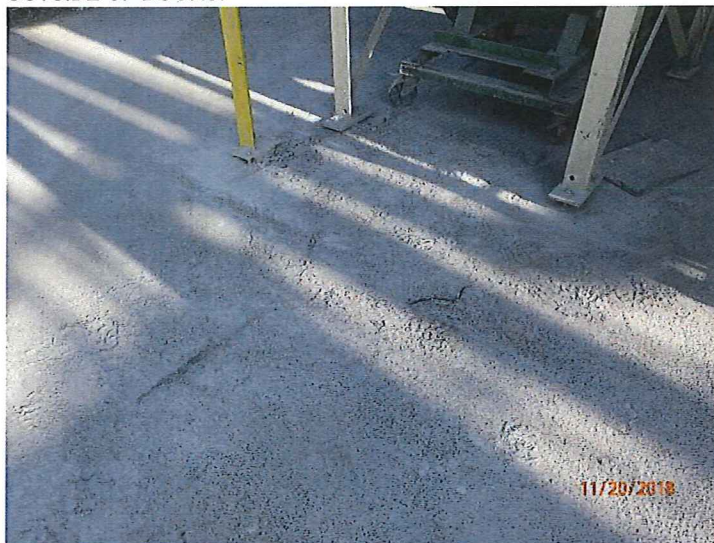
004 DESCRIPTION: HEAVY DUST ACCUMULATION ON GROUND AROUND BAG HOUSES IN DRAINAGE BASIN 1.

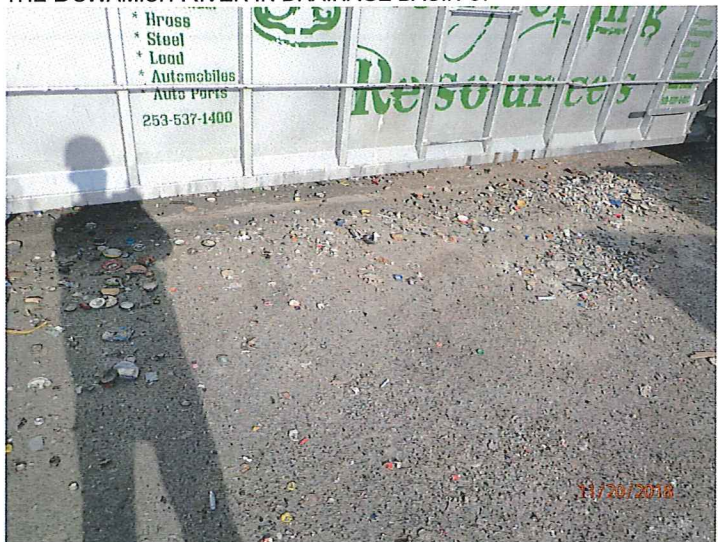
005 DESCRIPTION: DEBRIS AND SEDIMENT ACCUMULATION AT BASE OF DUMPSTER.

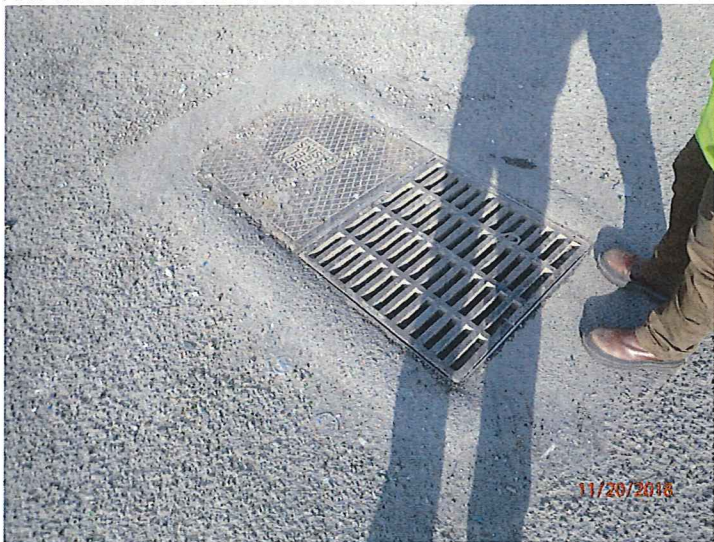
006 DESCRIPTION: TREATMENT CATCH BASIN IN DRAINAGE BASIN 3.

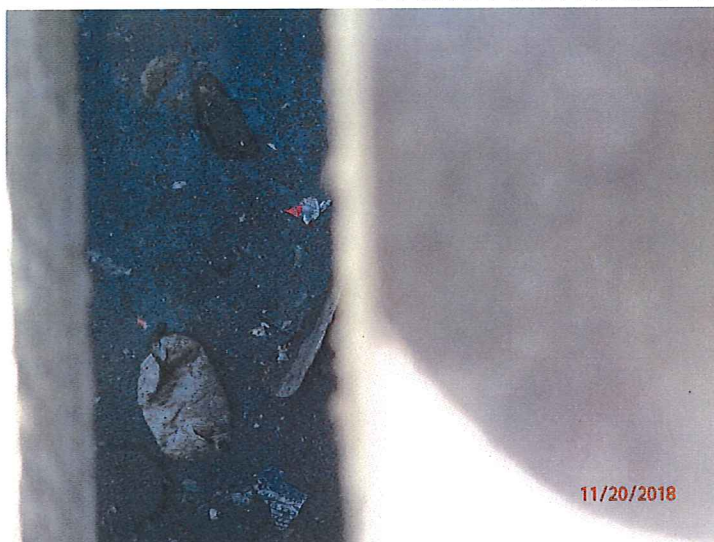
- All dumpsters are fitted with lids that are kept closed when not in use.
- Several of the catch basins on-site required maintenance to remove accumulated sediment and debris from the treatment media/filter inserts.

007 **DESCRIPTION:** HEAVY SEDIMENT AND DEBRIS ACCUMULATION ON TOP OF THE TREATMENT MEDIA INSIDE THE CATCH BASIN SHOWN IN PHOTO 006.

- **Ardagh Glass is in violation of permit condition S3.B.4.b.i.3, failure to maintain stormwater drainage/treatment BMPs.** Within 10 calendar days of receipt of this report, inspect all catch basin treatment BMPs, remove excess sediment and debris, and replace treatment media as necessary.

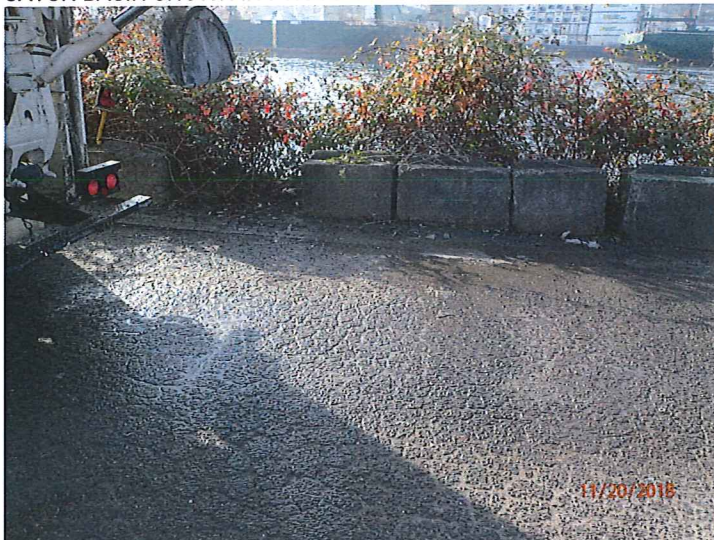
- A paving contractor was on-site performing concrete work during the inspection. We observed the operator of one of the concrete trucks washing out on-site in drainage basin 3, directly adjacent to the Duwamish River. The operator was attempting to collect the wash water in a five-gallon bucket, but much of it was spilling onto the ground. The operator stopped the washing activities when instructed to do so. Pavement staining that appeared to be from another concrete truck being washed out onto the ground was also observed in one location in drainage basin 2 during the inspection.

009 **DESCRIPTION:** CONCRETE WASHOUT WATER ON PAVEMENT ADJACENT TO THE RIVER. ALLIGATOR CRACKING ON PAVEMENT.

- **Ardagh Glass is in violation of permit condition S3.B.4.b.i.7.ii, failure to properly manage washwater.** Immediately ensure that all washing activities, including washout of concrete trucks, are conducted in areas where the washwater can be collected and properly disposed of. Washwater is considered a process water and cannot be

allowed to discharge to surface waters or the storm drainage system.

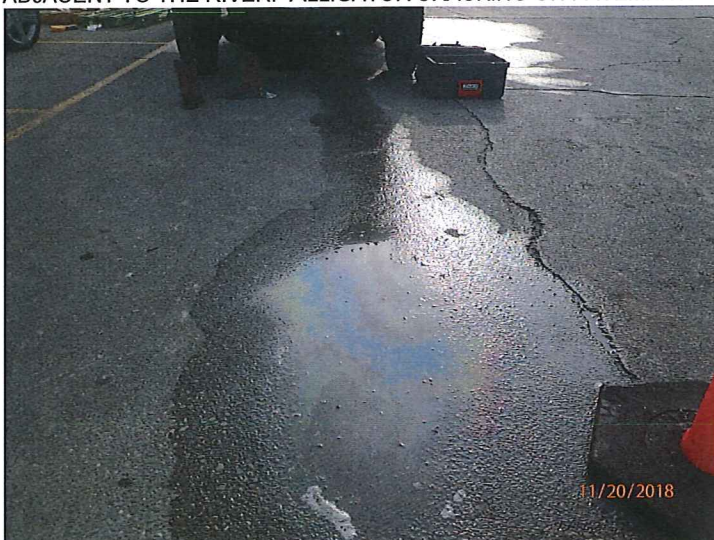
- A piece of heavy equipment and a contractor's truck were actively leaking fluid at the time of the inspection. No actions had yet been taken to contain or clean up the leaks when they were observed.

011 **DESCRIPTION:** SHEEN ON WATER FROM LEAKING CONTRACTOR TRUCK.

- **Ardagh Glass is in violation of permit condition S3.B.4.b.i.3.d, failure to immediately clean up spills and leaks.** Ensure that future spills and leaks are cleaned up immediately and that contaminated spill cleanup materials are properly disposed of. Ensure that appropriate staff are properly trained in the facility's procedures for identifying and responding to spills and leaks.

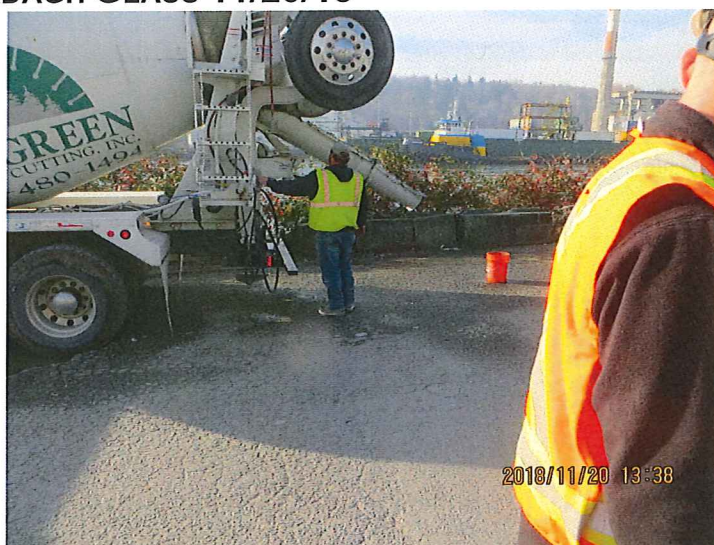
008 **DESCRIPTION:** CONCRETE TRUCK THAT WAS WASHED OUT ONTO THE GROUND ADJACENT TO THE DUWAMISH RIVER. ALLIGATOR CRACKING ON PAVEMENT IN FOREGROUND OF PHOTO.

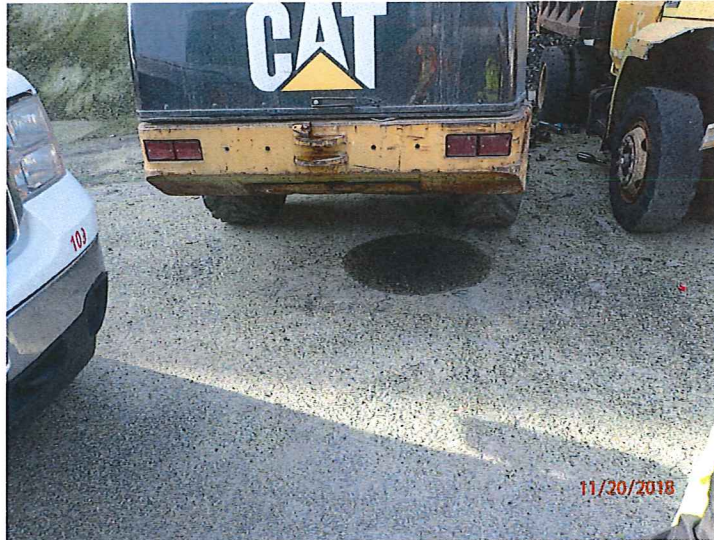
010 **DESCRIPTION:** HEAVY EQUIPMENT LEAKING ONTO THE GROUND.

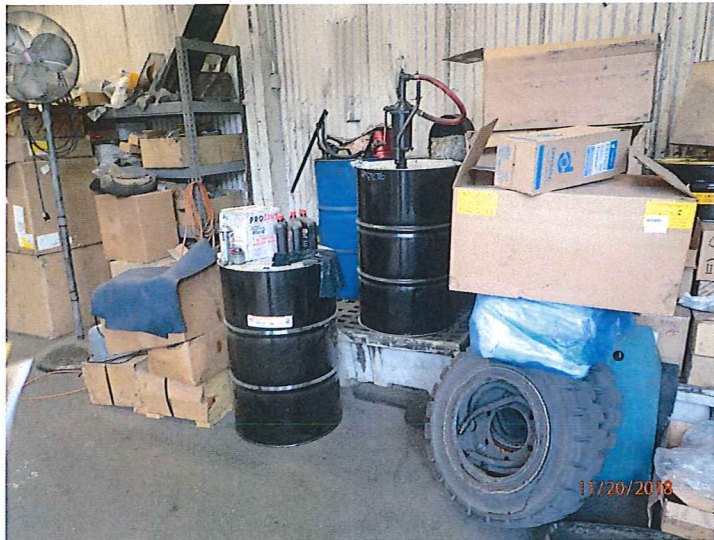
- Spill kits were stored in multiple locations on-site.
- The facility has an on-site maintenance shop for their equipment. The majority of liquid products in the shop were stored on a secondary containment pallet; however, one 55-gallon drum of oil and a few miscellaneous containers of automotive fluids did not have containment. The maintenance shop is relatively small and has a door that opens to the outside, so liquid spills outside of containment could reach the outside.

012 **DESCRIPTION:** 55-GALLON OIL DRUM OFF OF SECONDARY CONTAINMENT PALLET IN THE MAINTENANCE SHOP.

- In accordance with permit condition S3.B.4.b.i.4.a, ensure that containers of chemical liquids, fluids, and petroleum products kept in the maintenance shop are stored in secondary containment. Though these materials are stored inside, the small size of the shop and proximity to the outdoors creates a possibility that spills could reach the storm drainage system.
